TECHNICAL INSPECTION REPORT

6 OPERATION CROSSROADS.
U.S.S. CRITTENDEN (APA 77)

TEST ABLE.

VOLUME 2 [U].

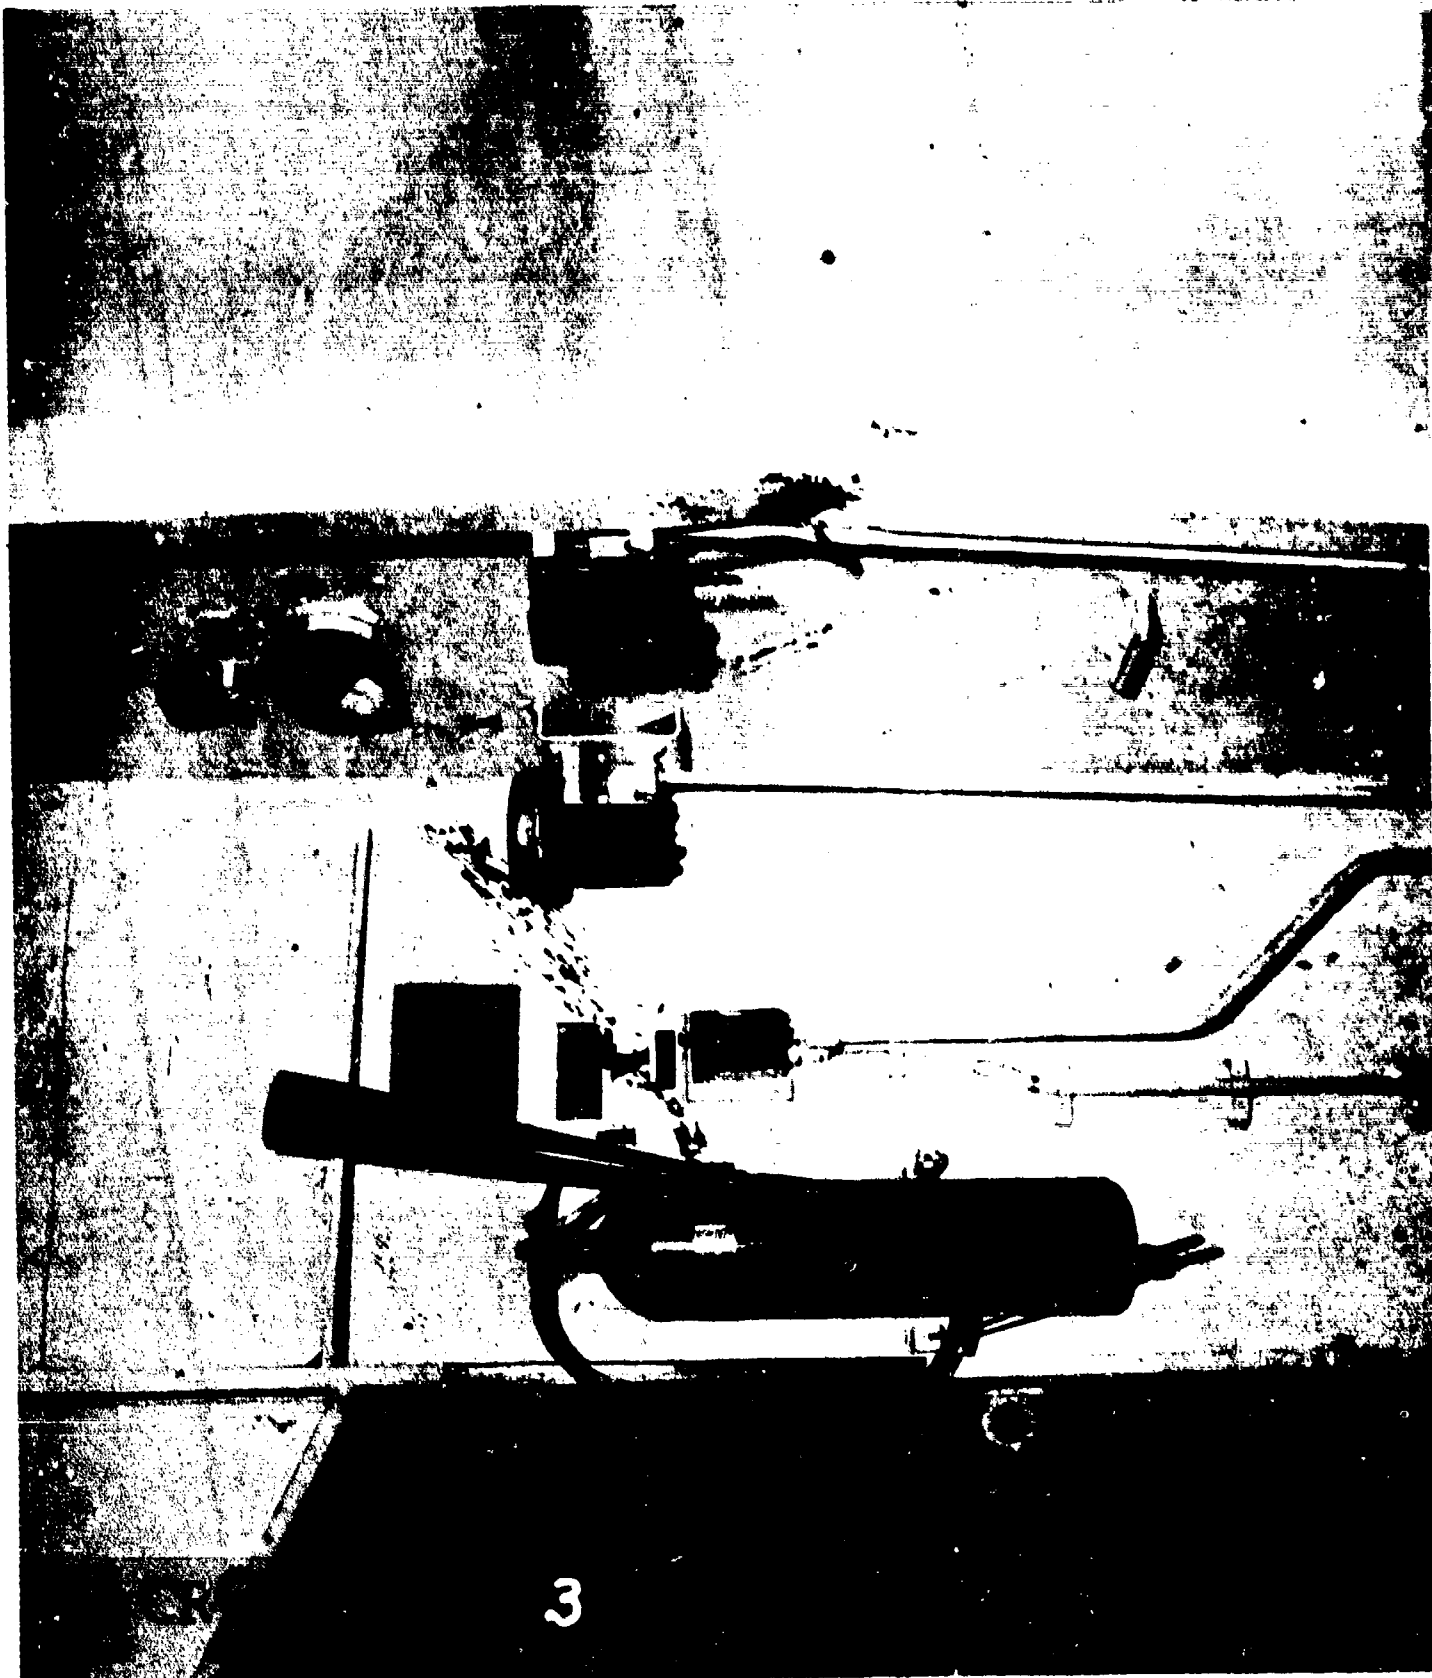
AA-CR-80-1908-3. Dished bulkhead 40 and stress pattern in column at frame 40 port.

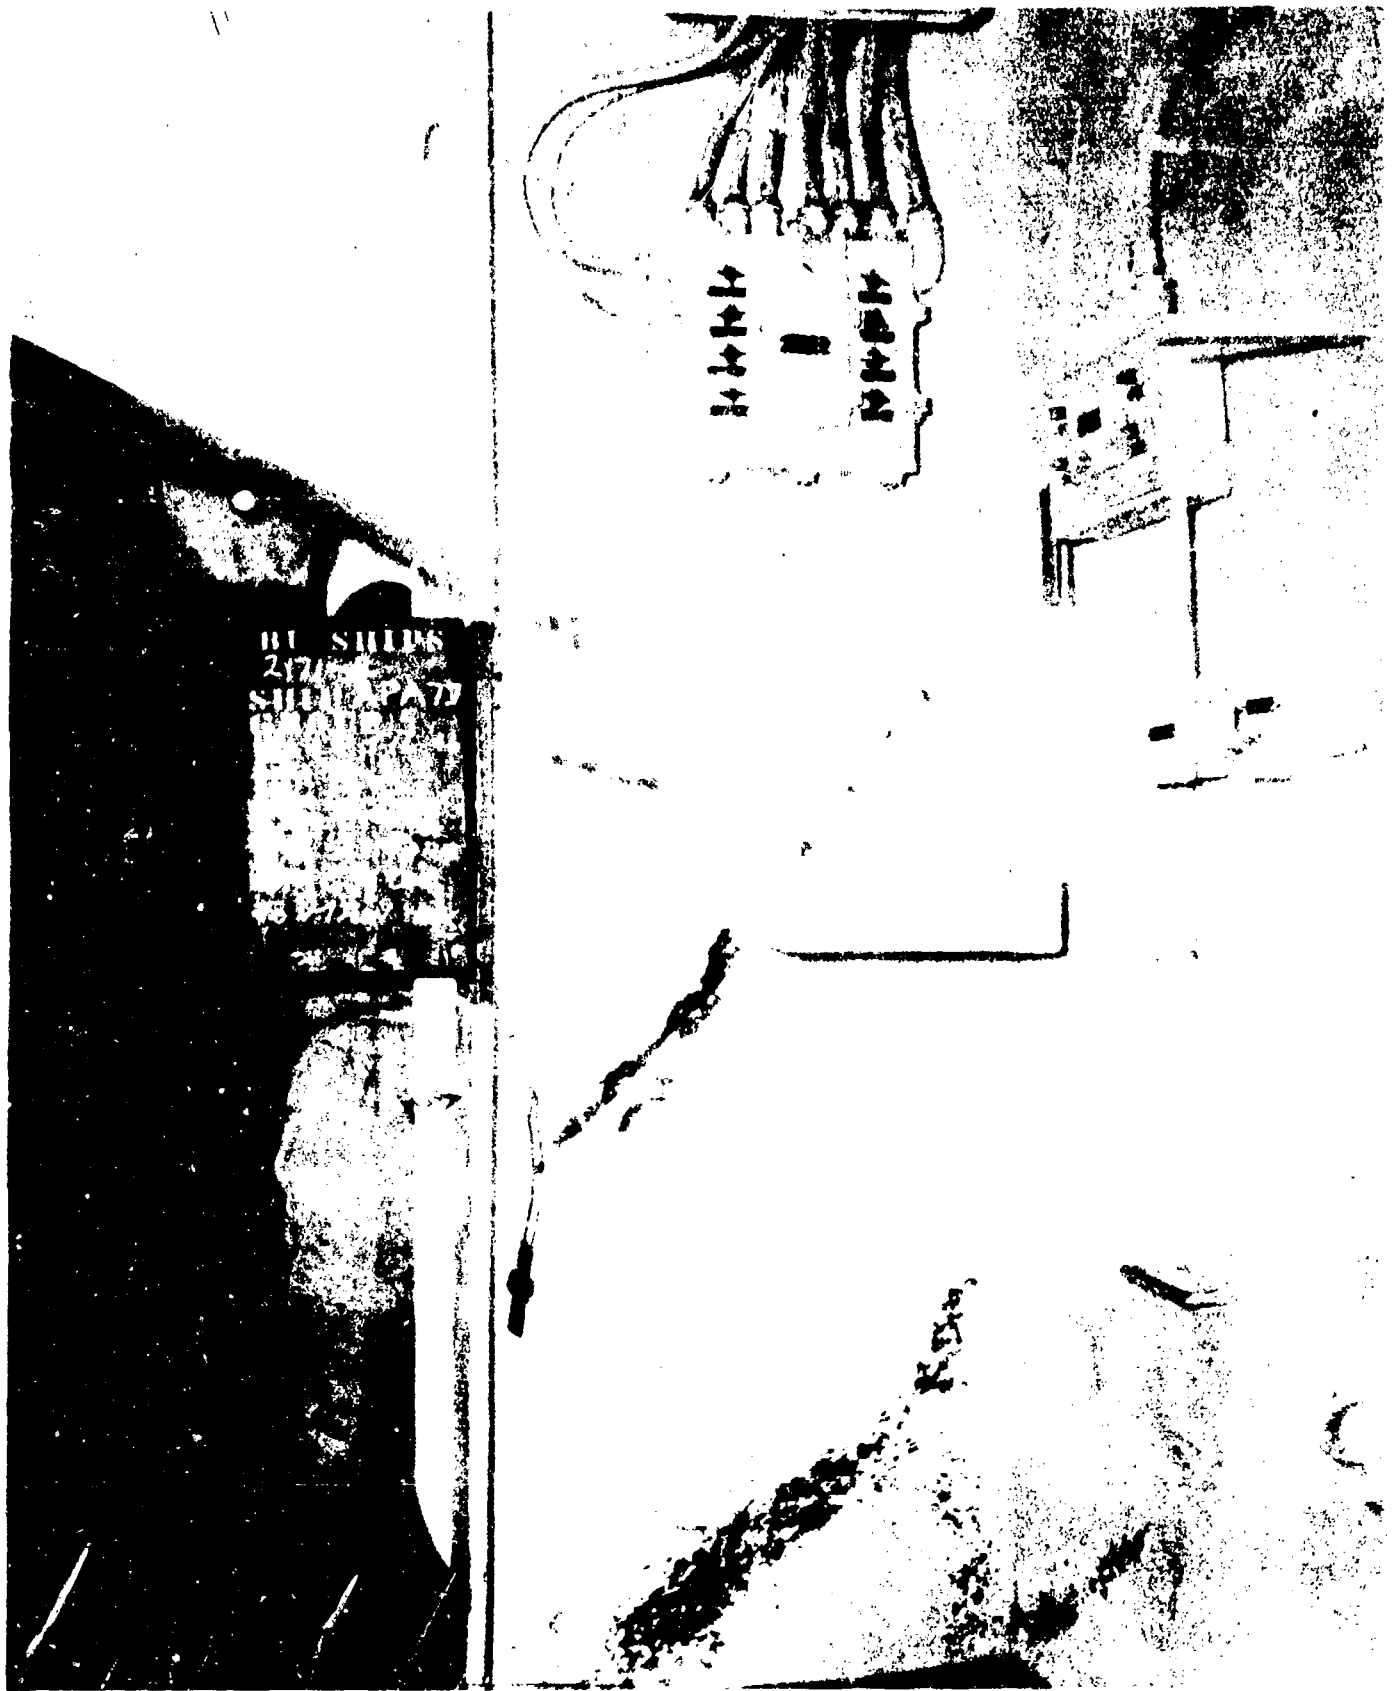
AA-CR-62-2171-9. Looking to port on main deck showing damage to port column at after side of bulkhead 27.

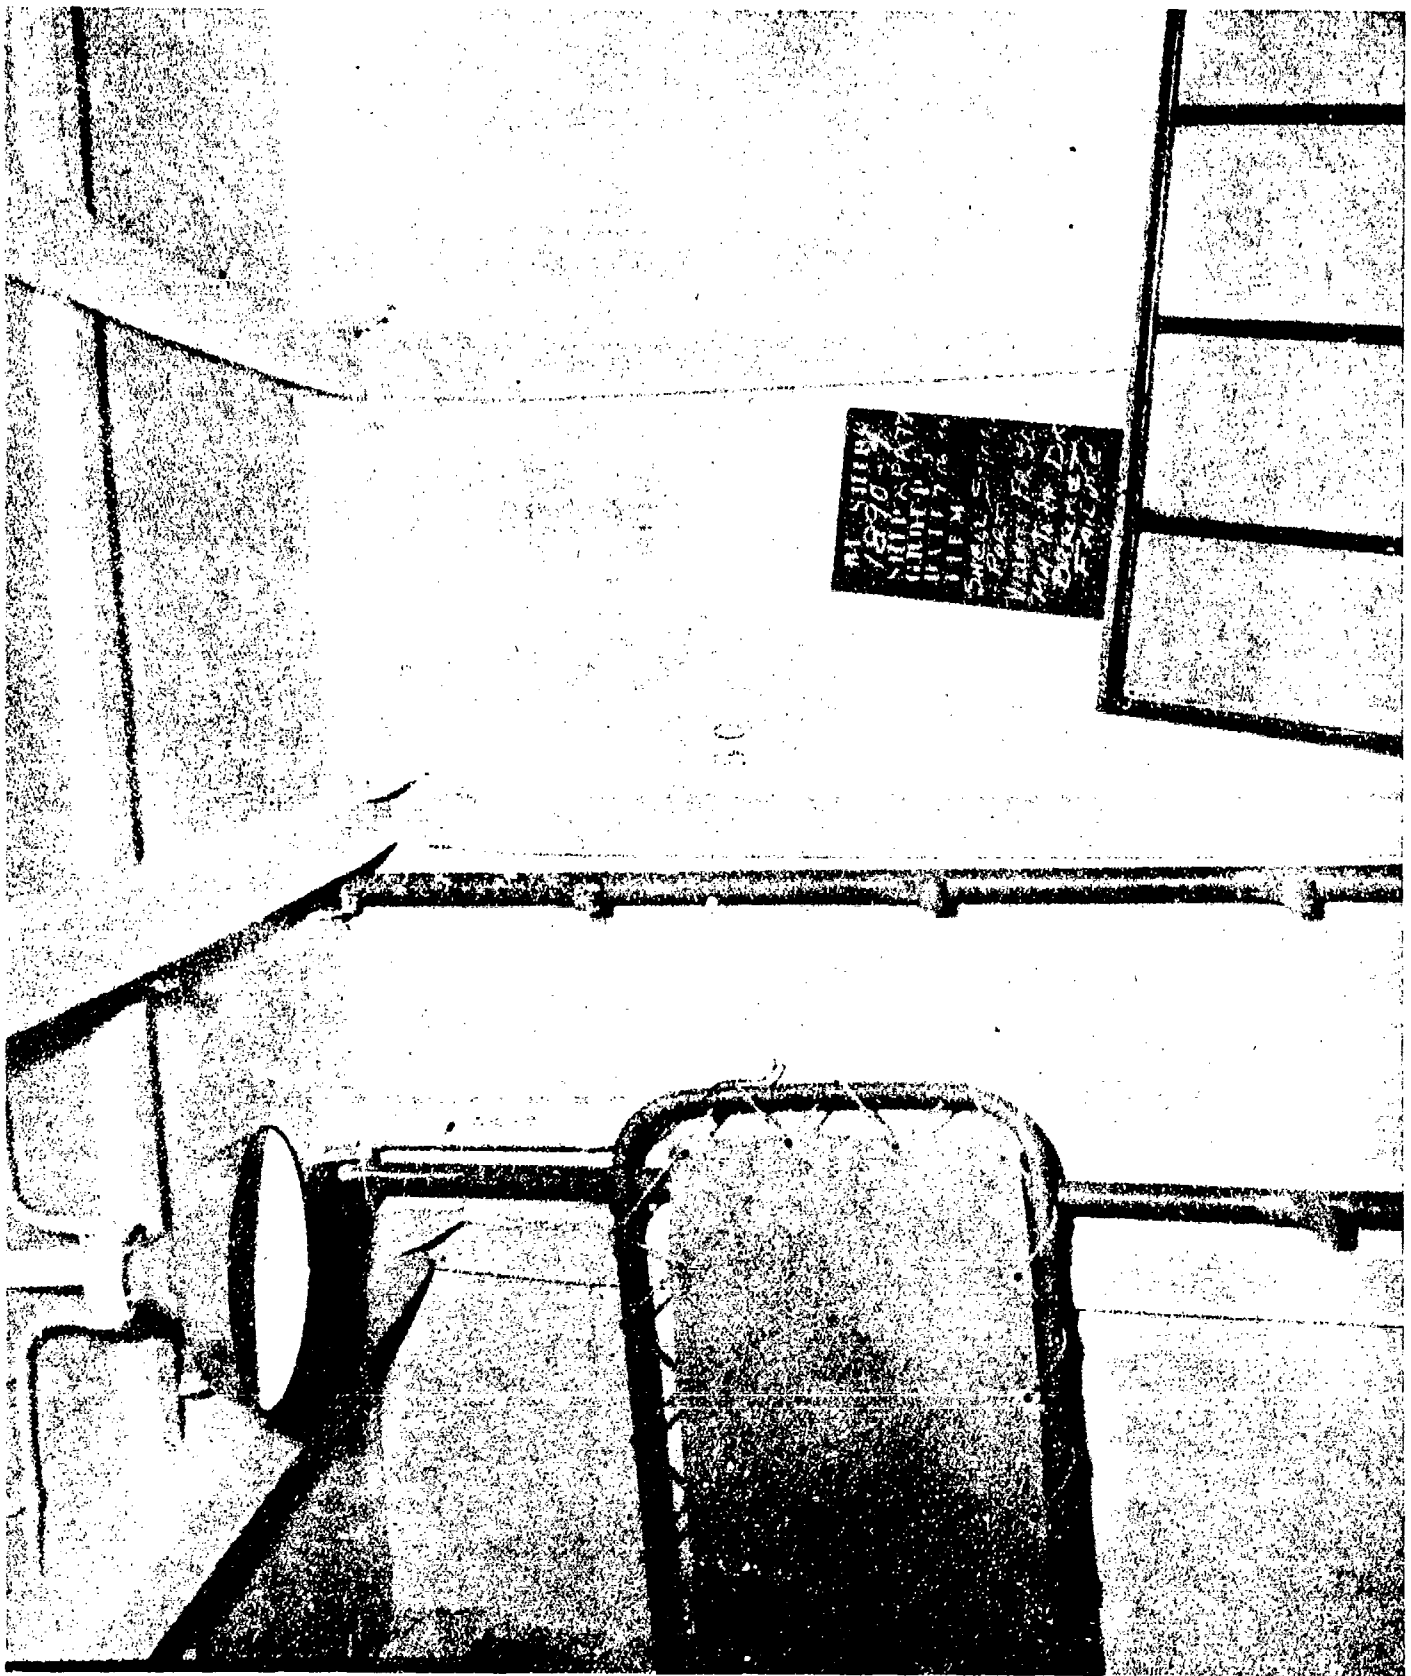
AA-CR-100-1890-7. Looking to port on main deck in crews berthing A-104L showing damage to brackets and stiffeners under upper deck, frame 49 to 52.

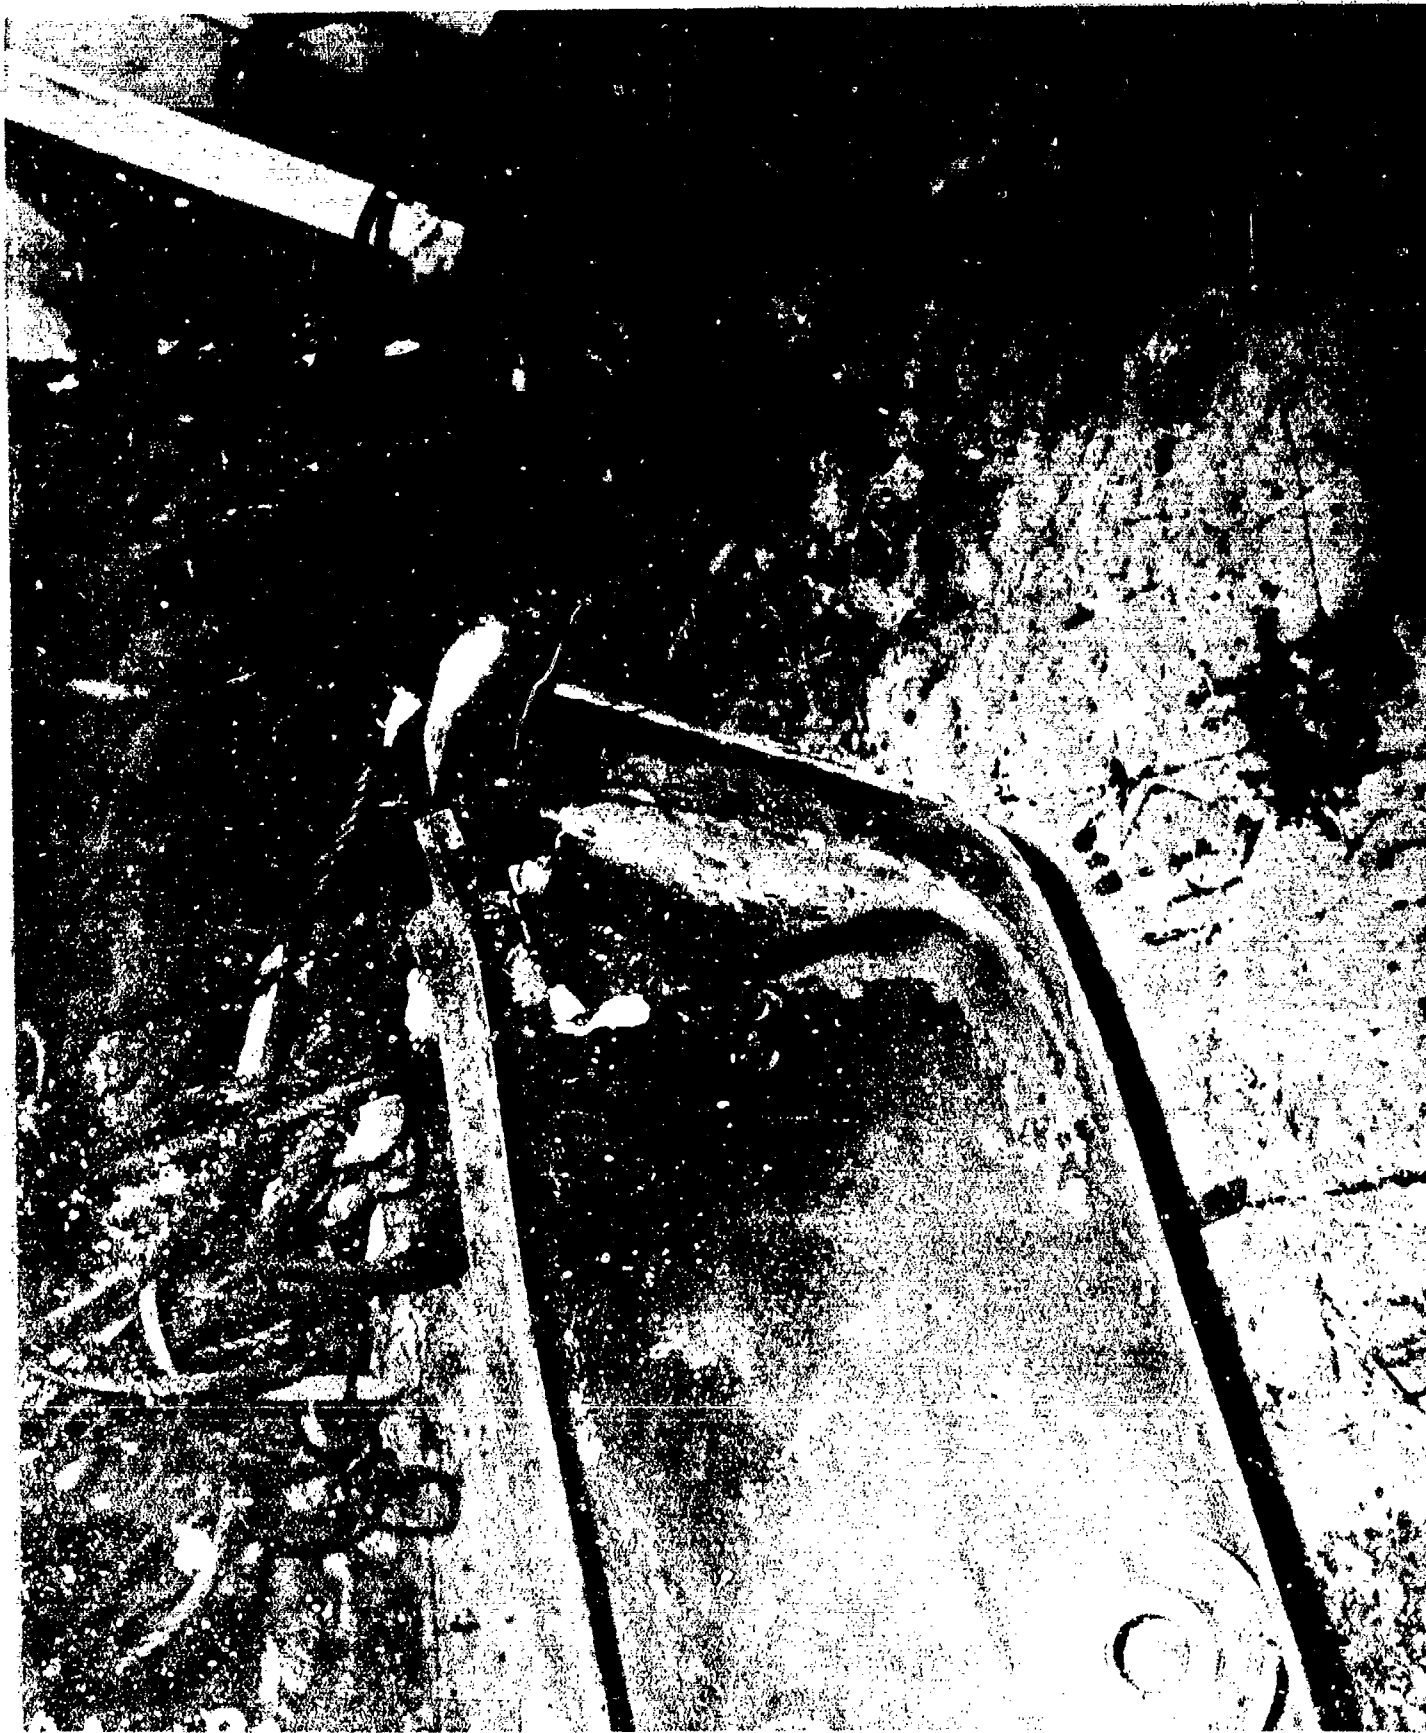
AA-CR-60-1908-4. View in after cargo hold showing close-up of end
of strong-back from upper deck level.

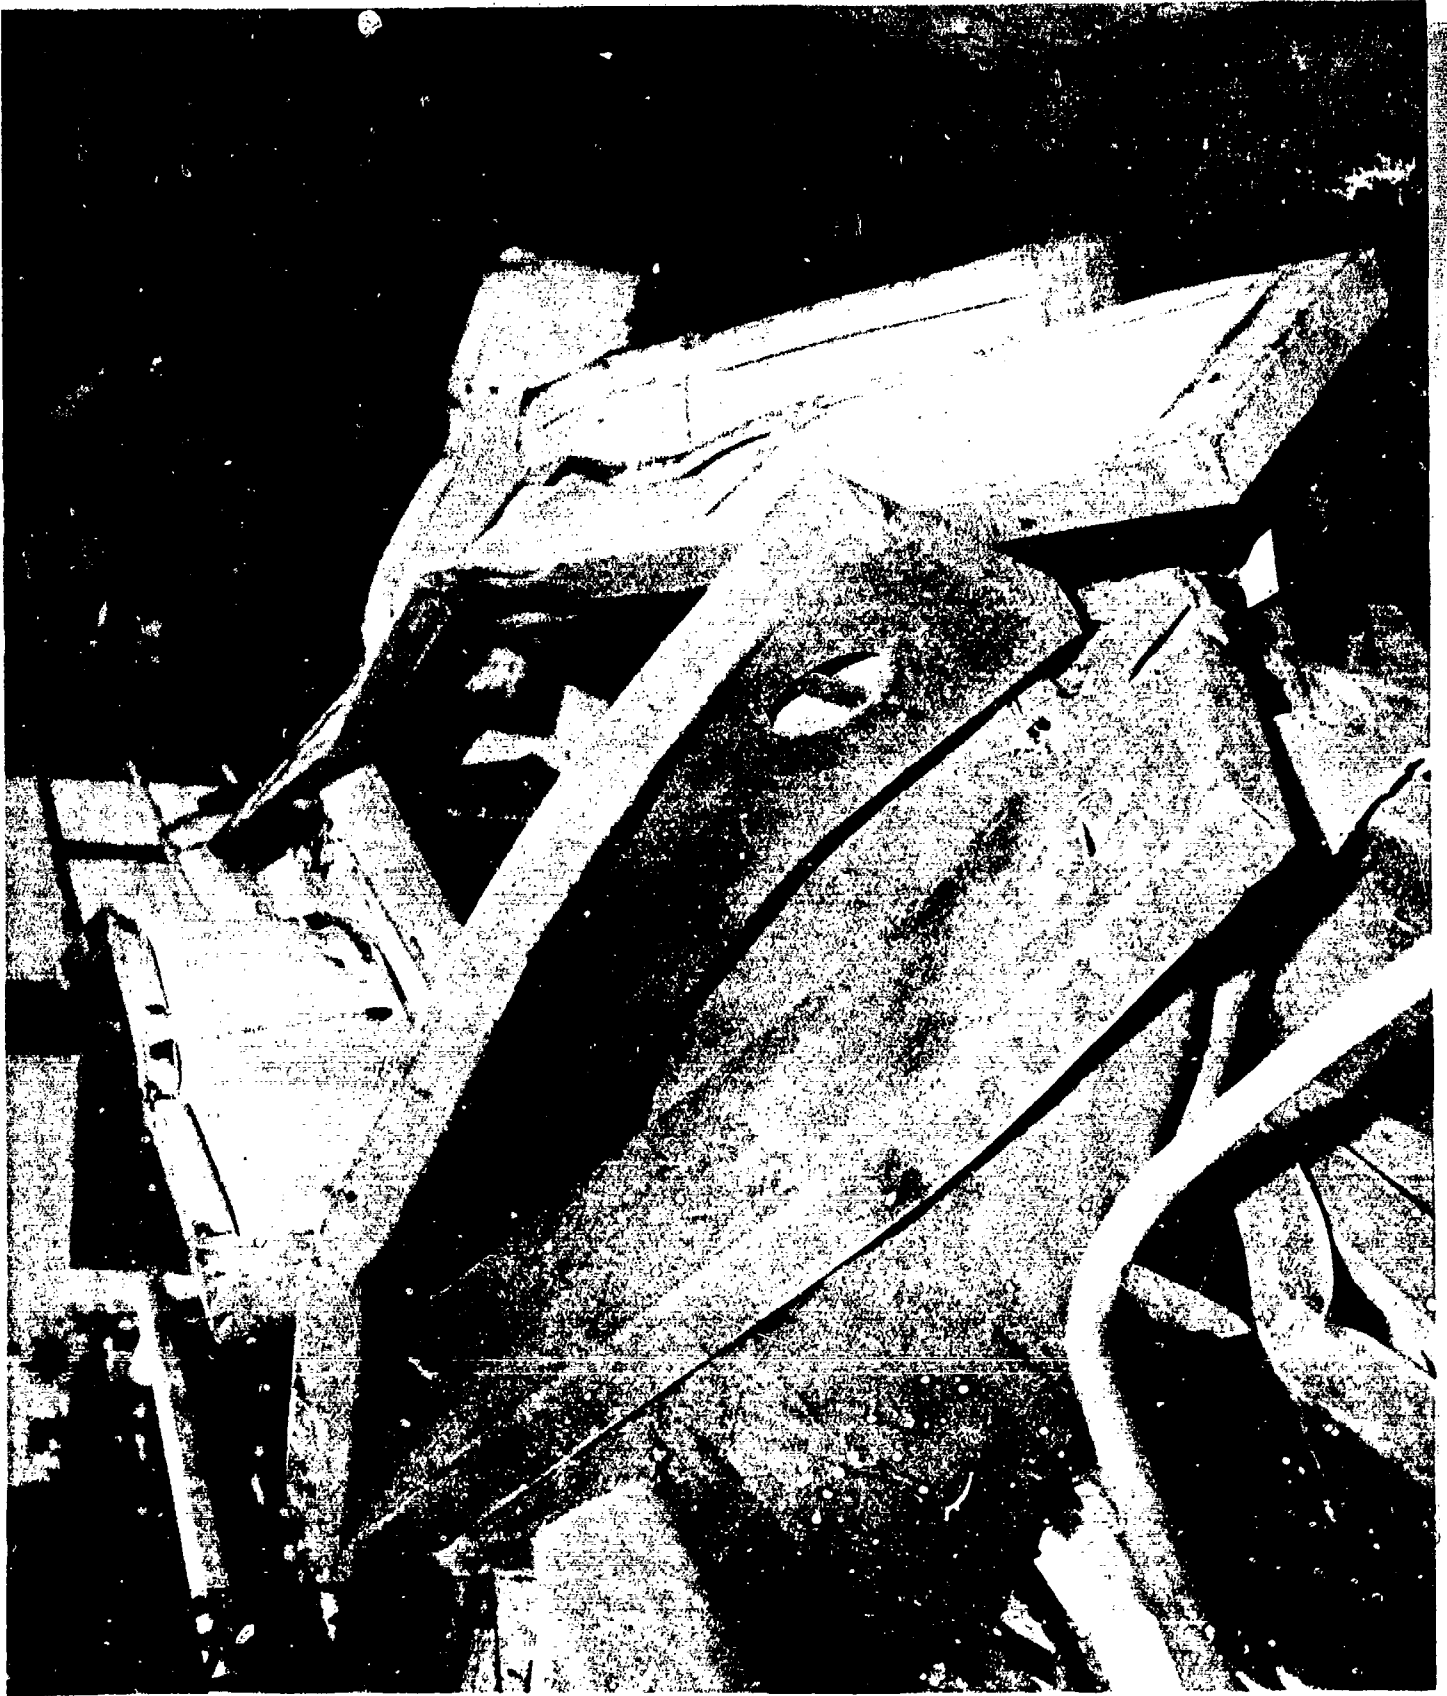
AA-CR-80-1907-3. Bent upper deck hatch cover panels.

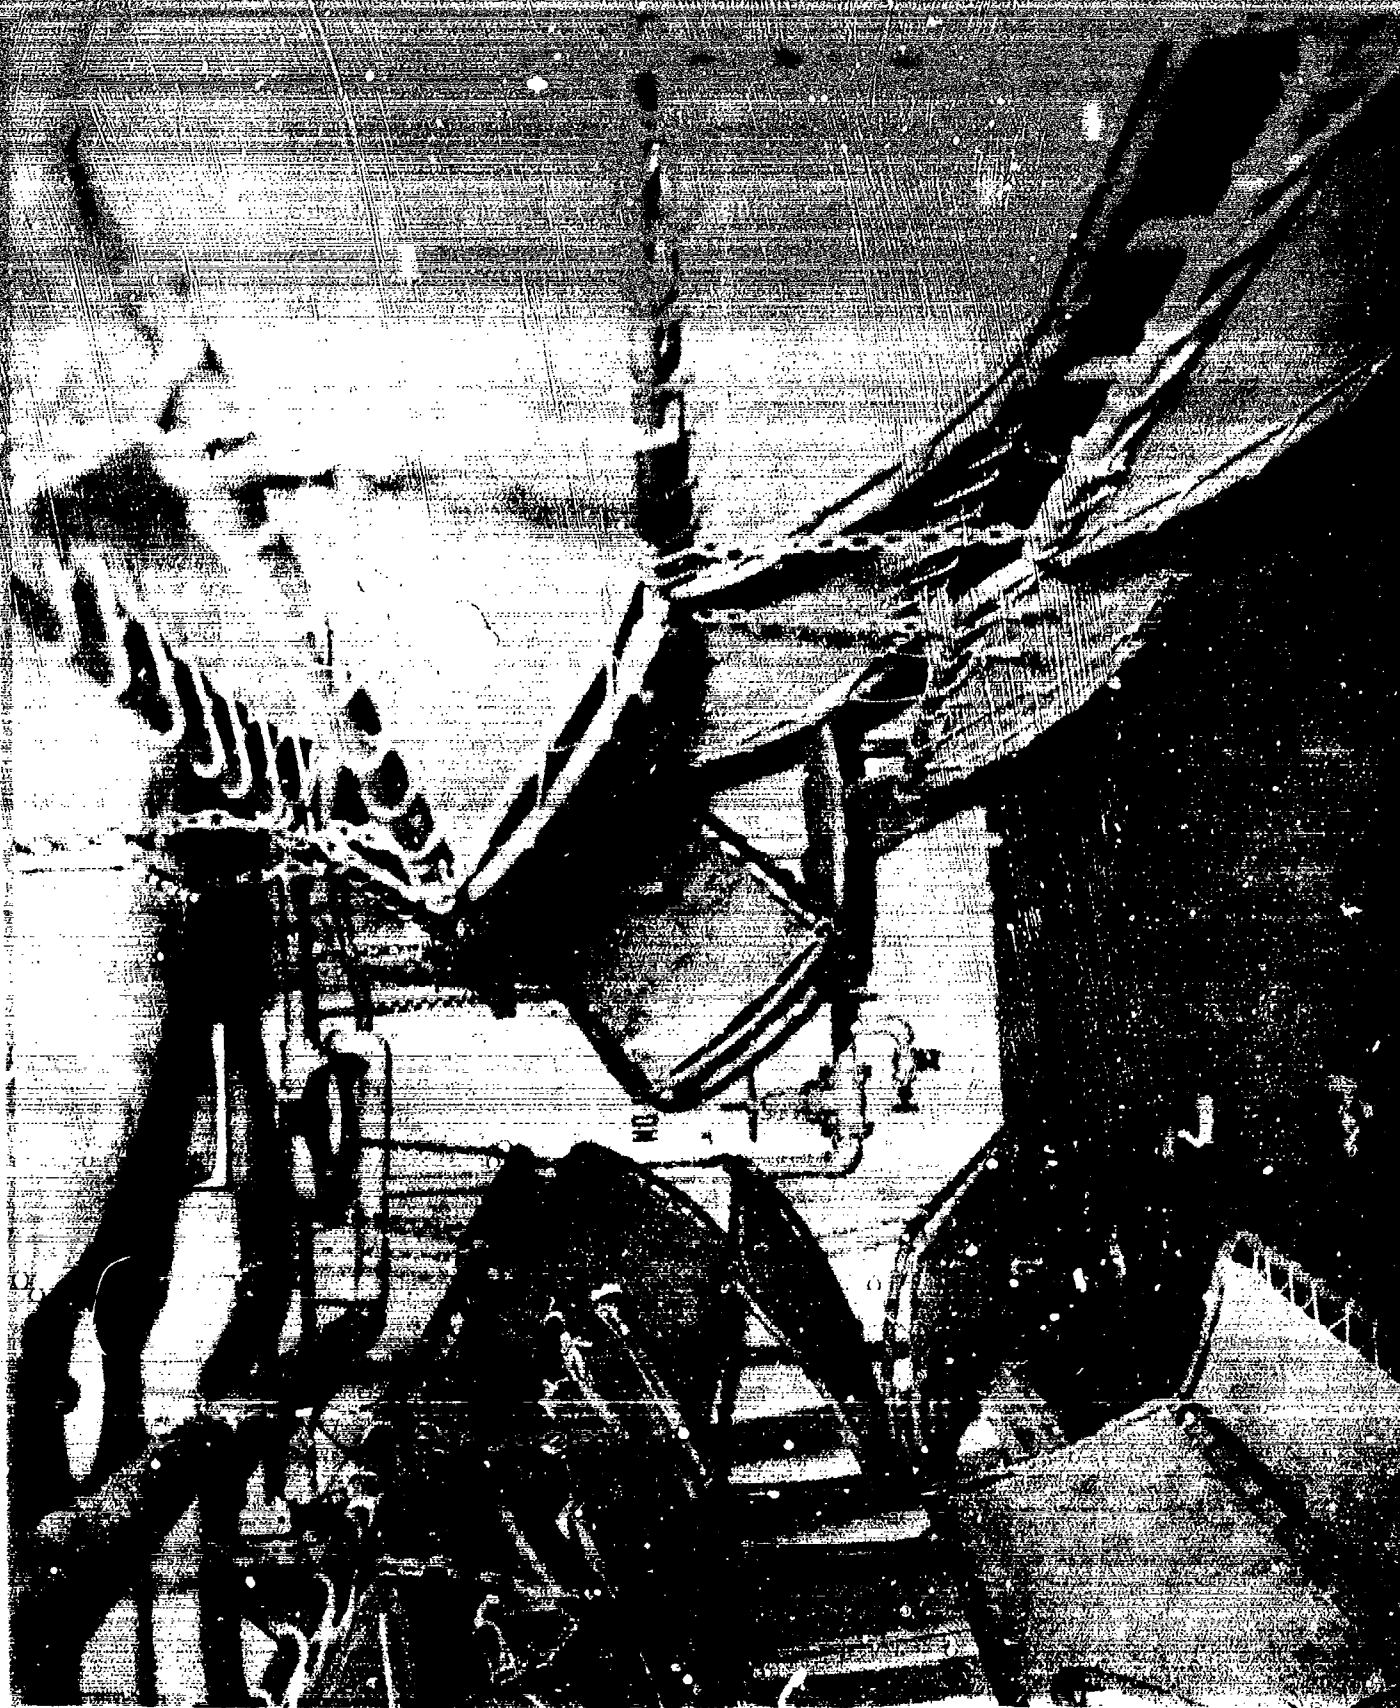
AA-CR-80-1908-12. Disarranged berths in crew's space aft of number two hold.

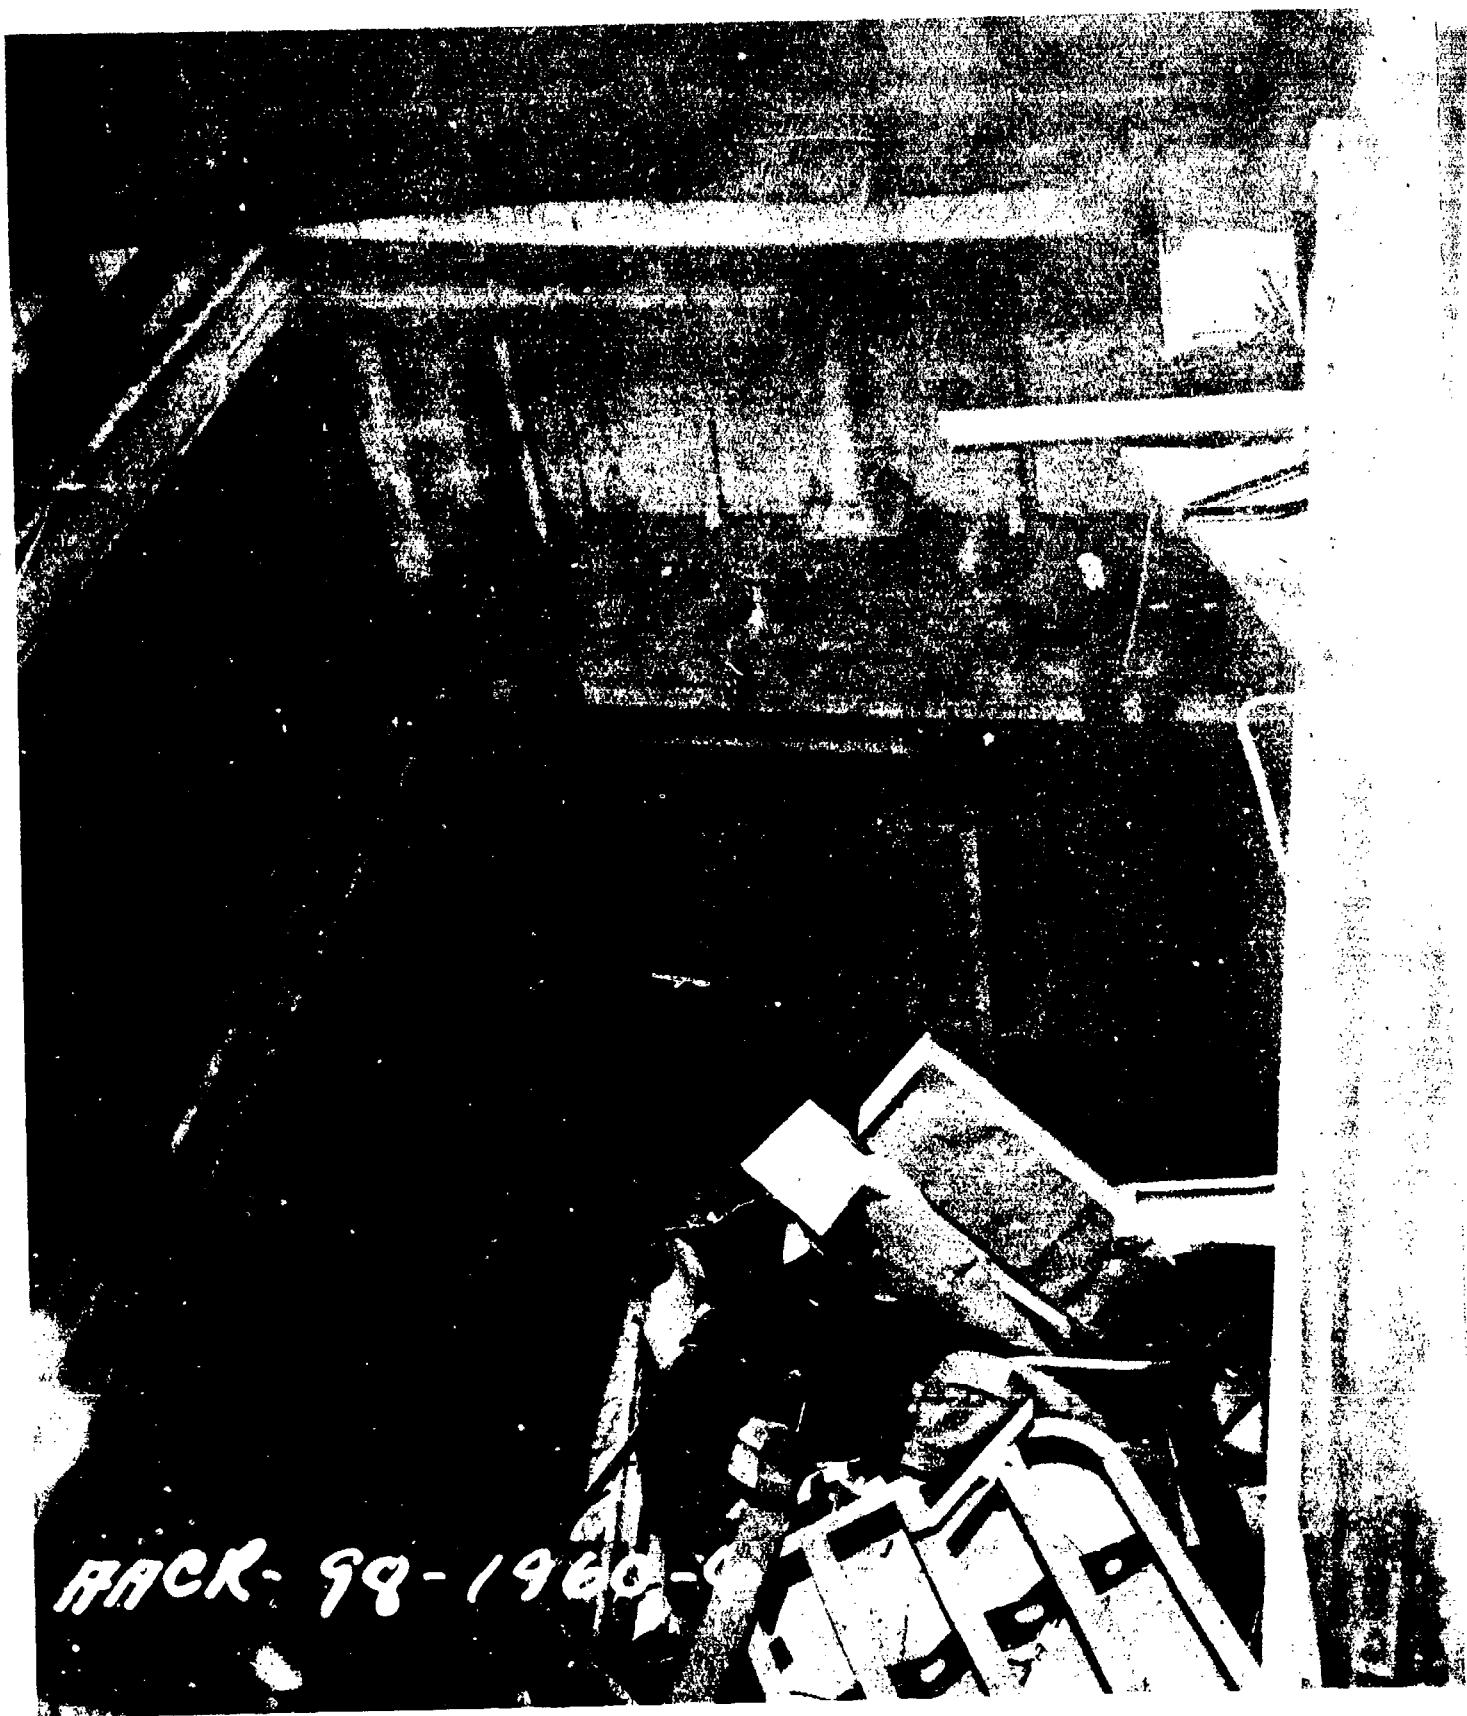
AA-CR-98-1960-6. Looking forward and down into forward cargo hold showing main deck level, first platform level, and wreckage in hold.

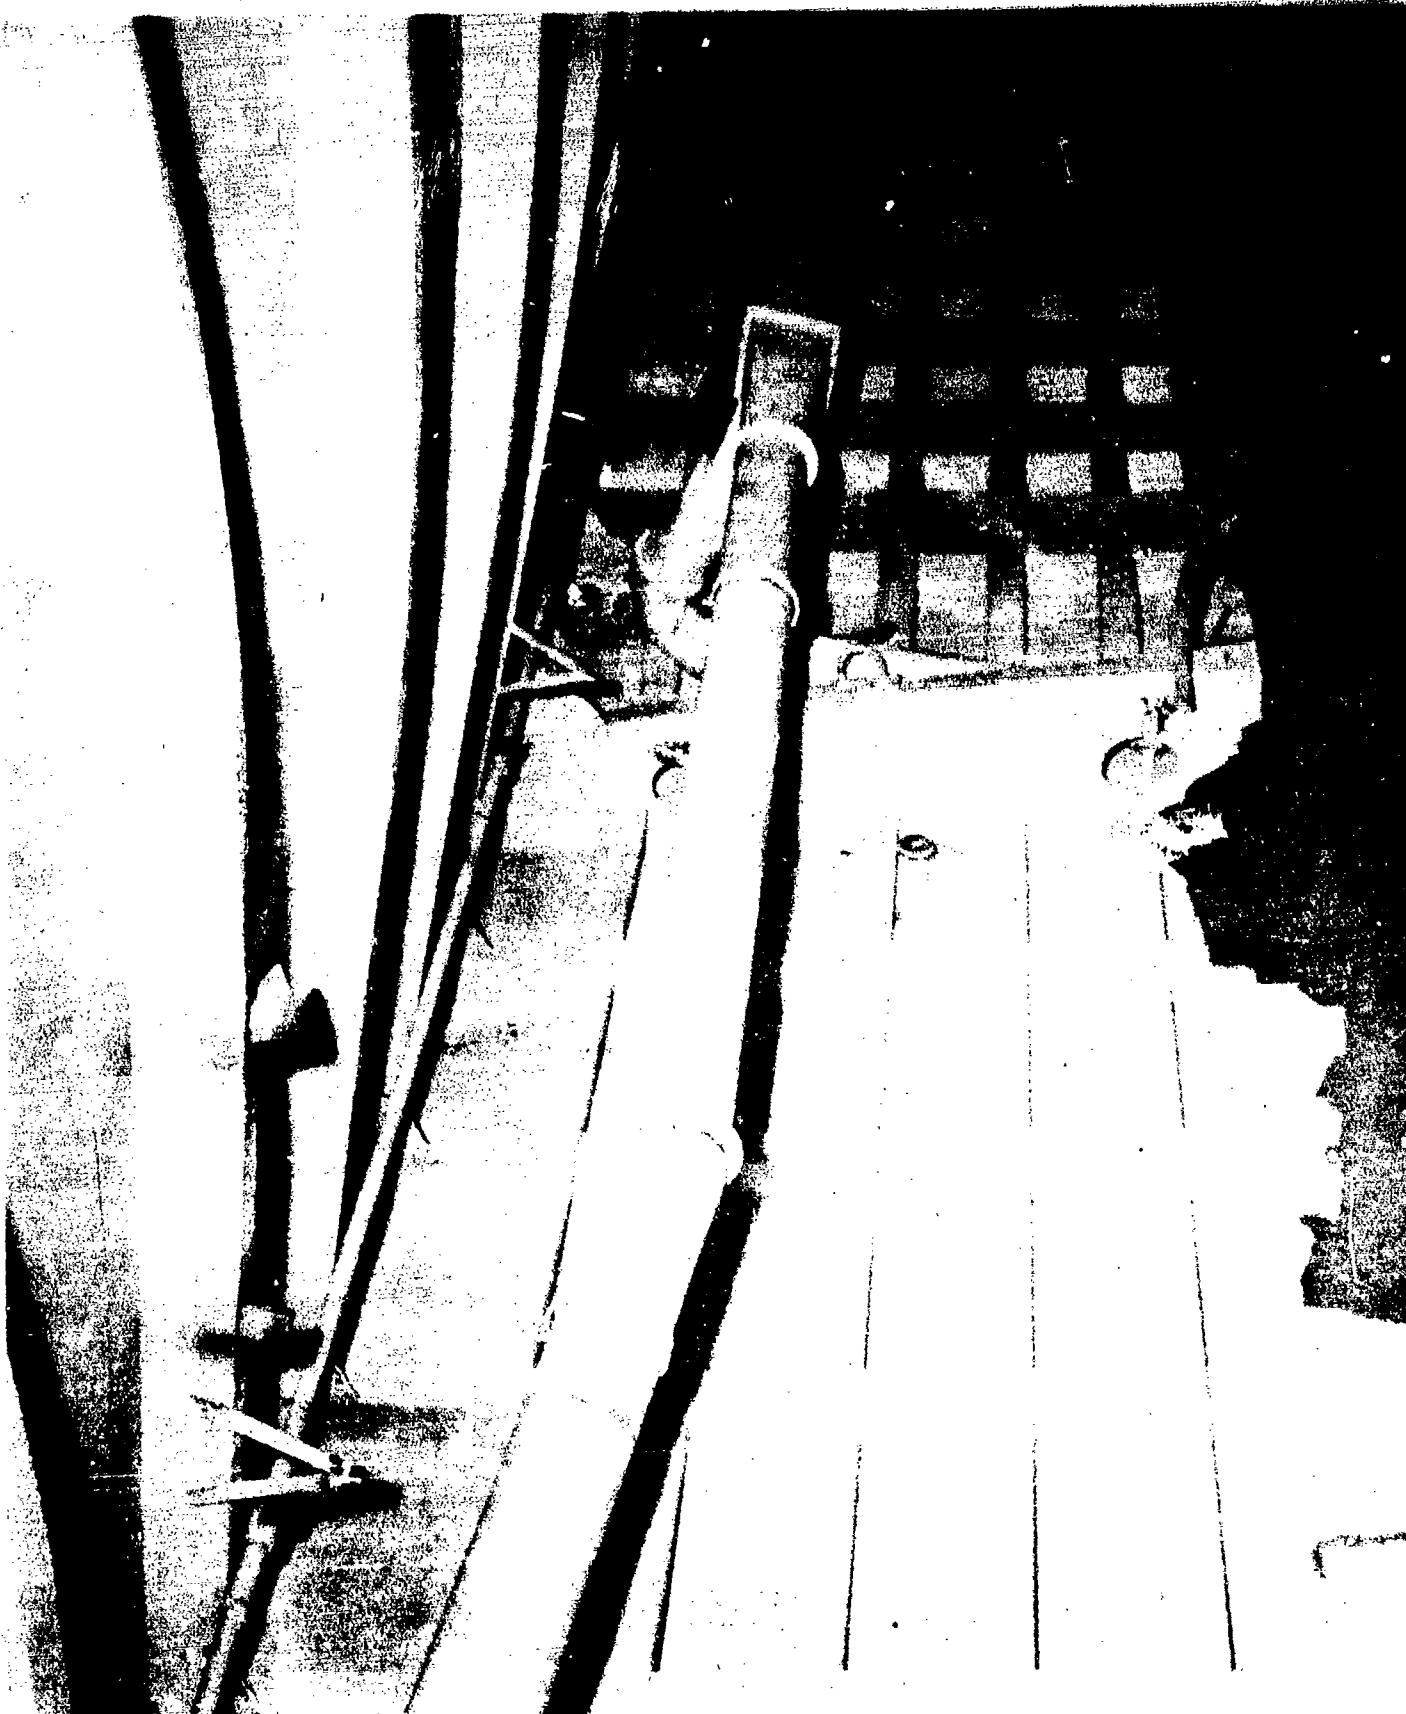
AA-CR-100-1890-11. Looking to starboard on first platform in forward cargo hatch area showing damage to web frame 48 and to brackets under main deck at starboard shell. Refer to 2086-7.

AA-CR-59-2086-7. Looking aft and to starboard on first platform in forward cargo hatch area showing deflected beams under main deck and separated ventilation duct.

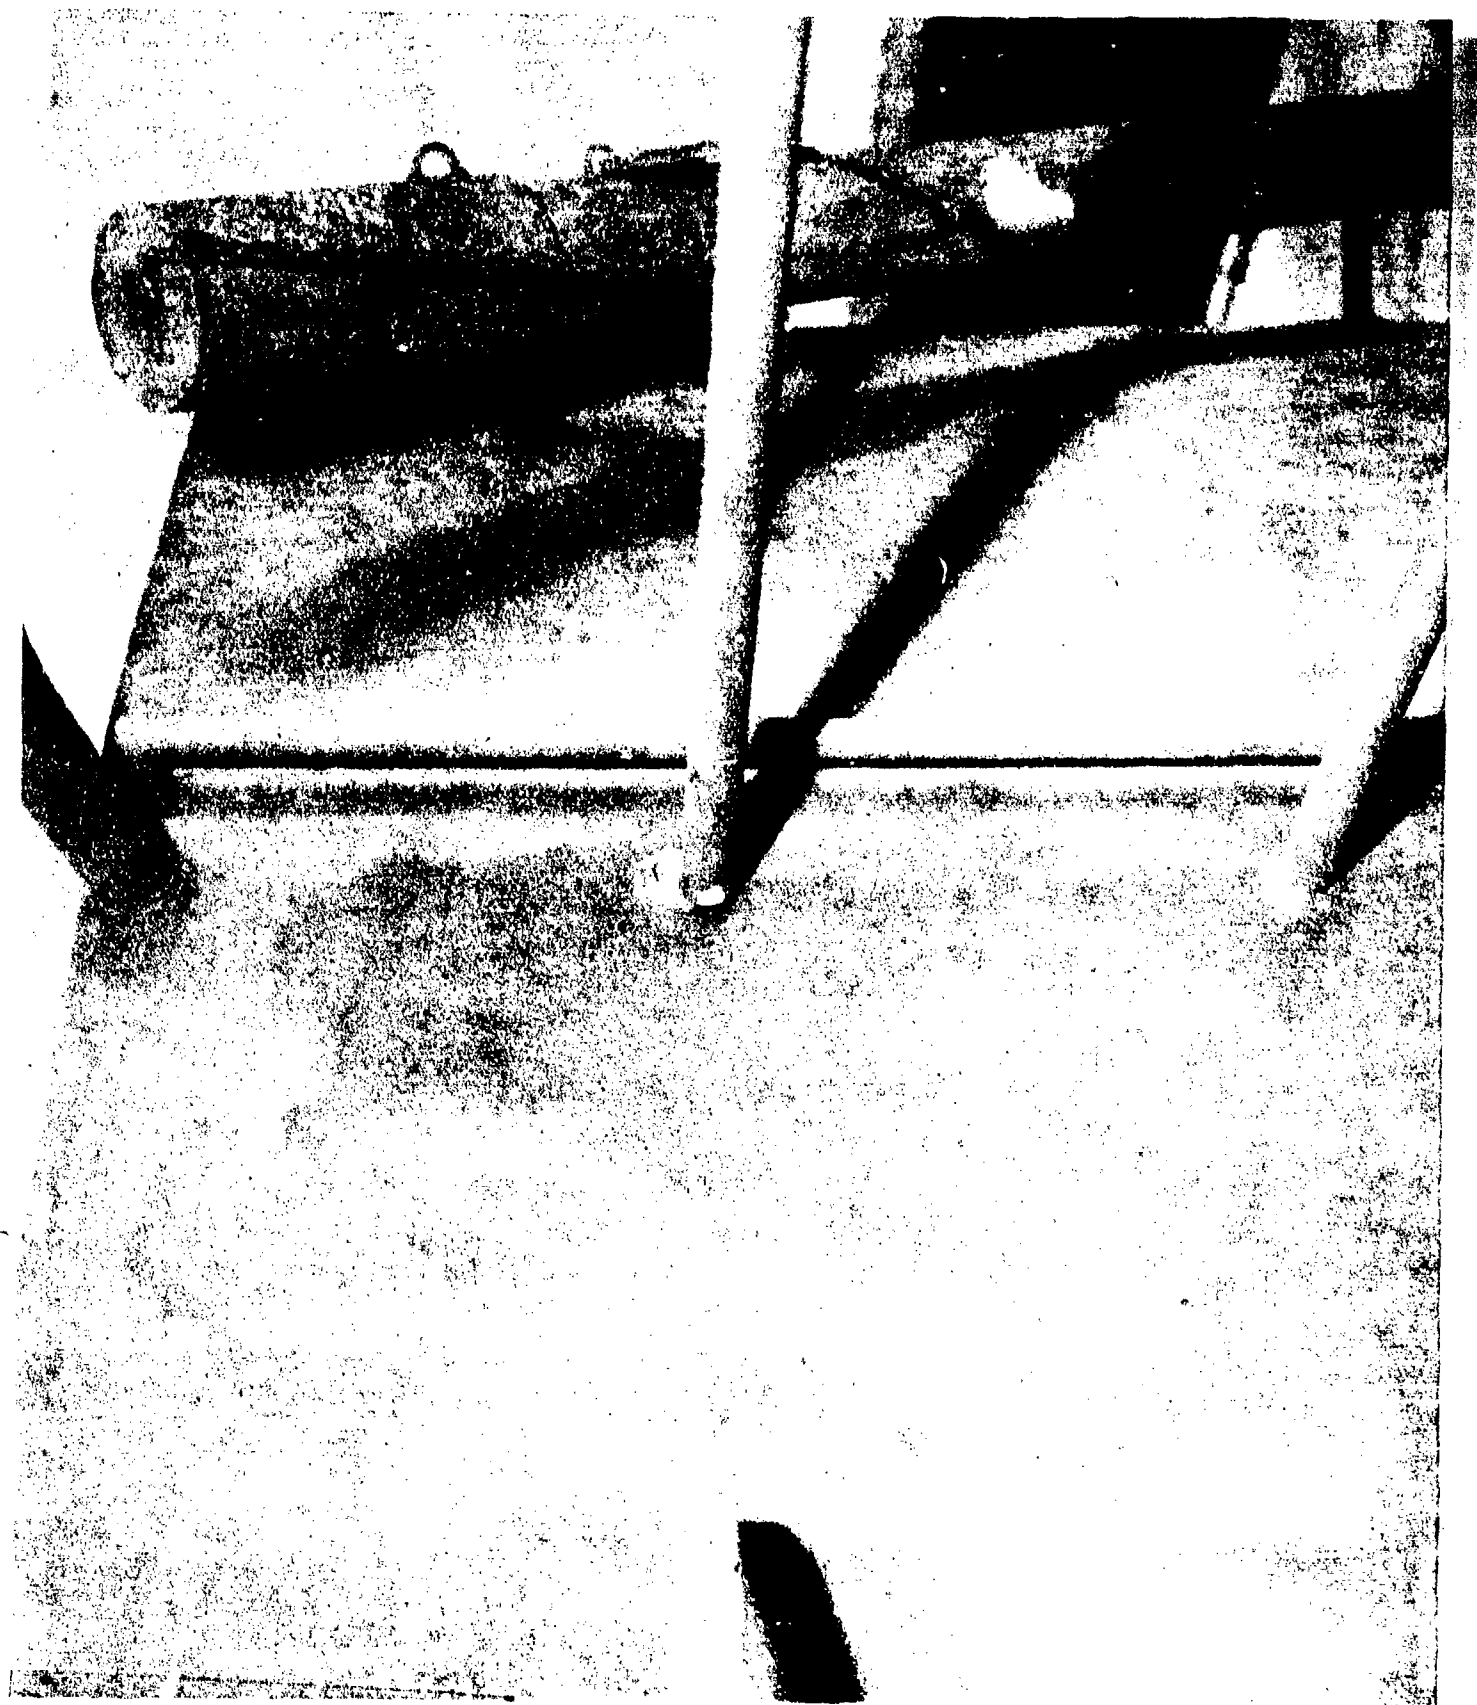
AA-CR-65-1817-8. Looking aft and to port on signal bridge level, port, showing scorched paint on 20MM gun tub.
